Geomorphic Assessment Report and Watershed Plan

Black Brook

Laconia and Gilford, New Hampshire

June 30, 2016. Revised July 7, 2016

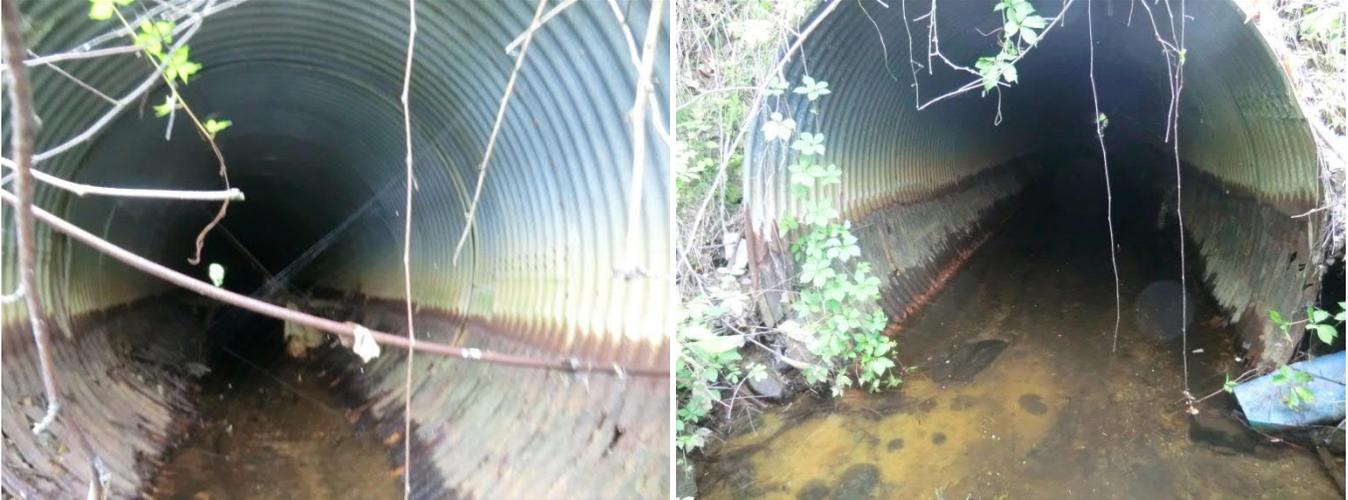
14	M02C	Kelso Motors	Culvert	6.1 5.75	188	Corrugated steel vert ellipse outlet Corrugated steel arch at inlet

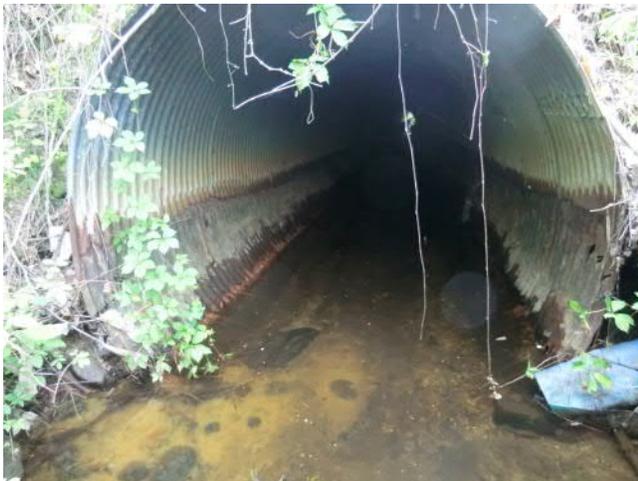
Photo 1

Selected undersized culverts in Reach M02B that are candidate for replacement. All from Blaisdell Avenue upstream are undersized, in addition to those shown on map above.

Typical undersized culvert

Considerations for Prioritization: Given the expense and number of culverts, this is best implemented on an ongoing basis as culverts fail and need to be replaced.

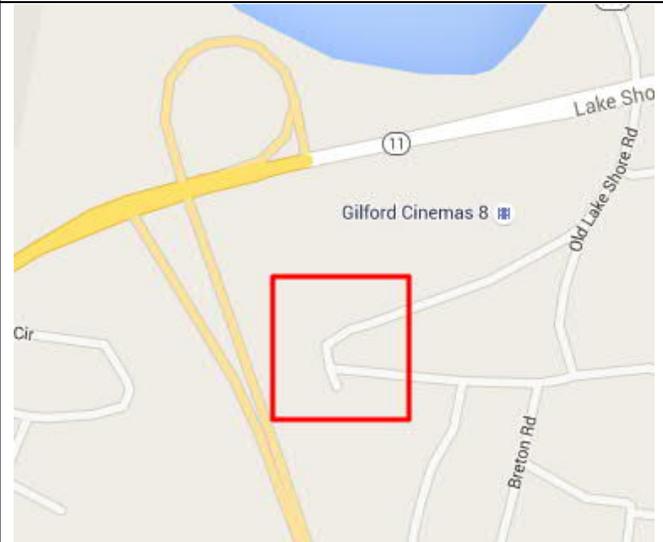
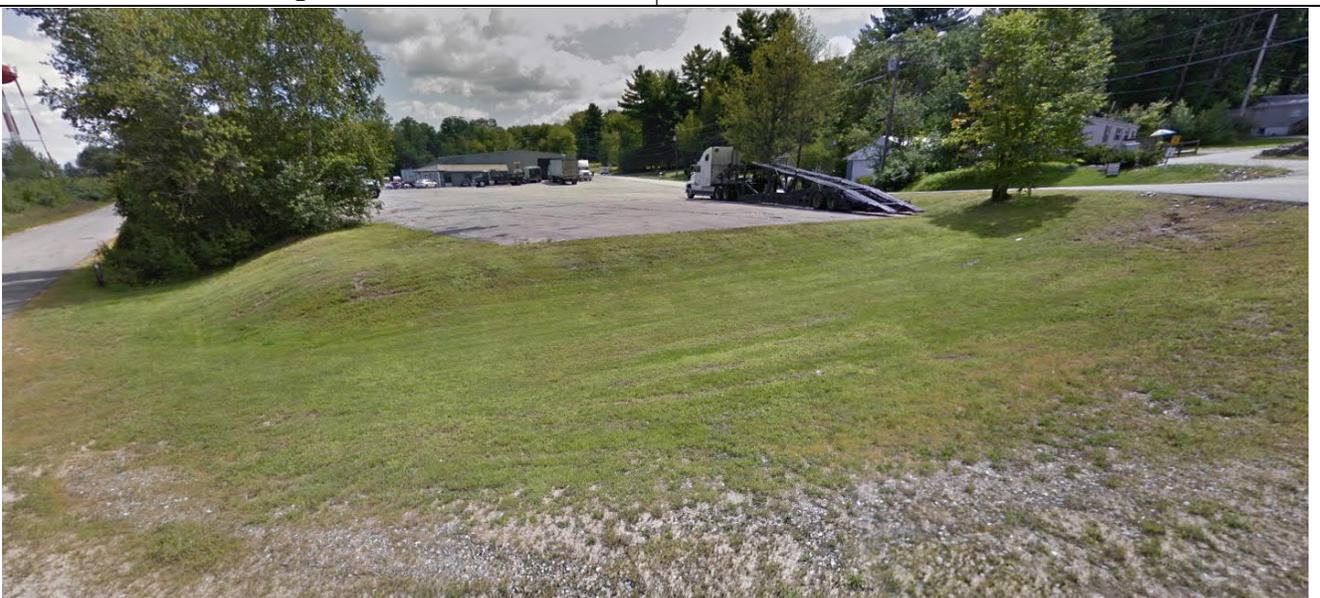
Annis Drive Loop. Restore stream (140 LF) and create floodplain on left bank

Site Issues and Relevance to the Watershed Plan Objectives:
 Removing the pipes and restoring the channel and floodplain will allow high flows and sediment to spill out of the channel and deposit on the floodplain. Owner would lose use of west end of lot.

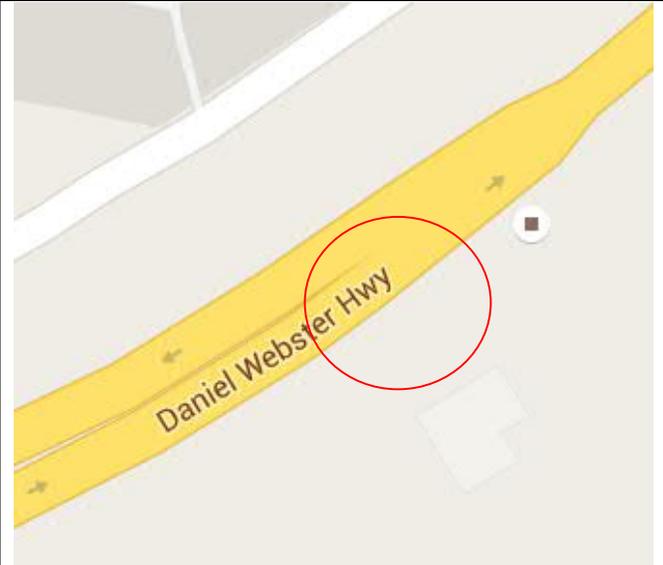
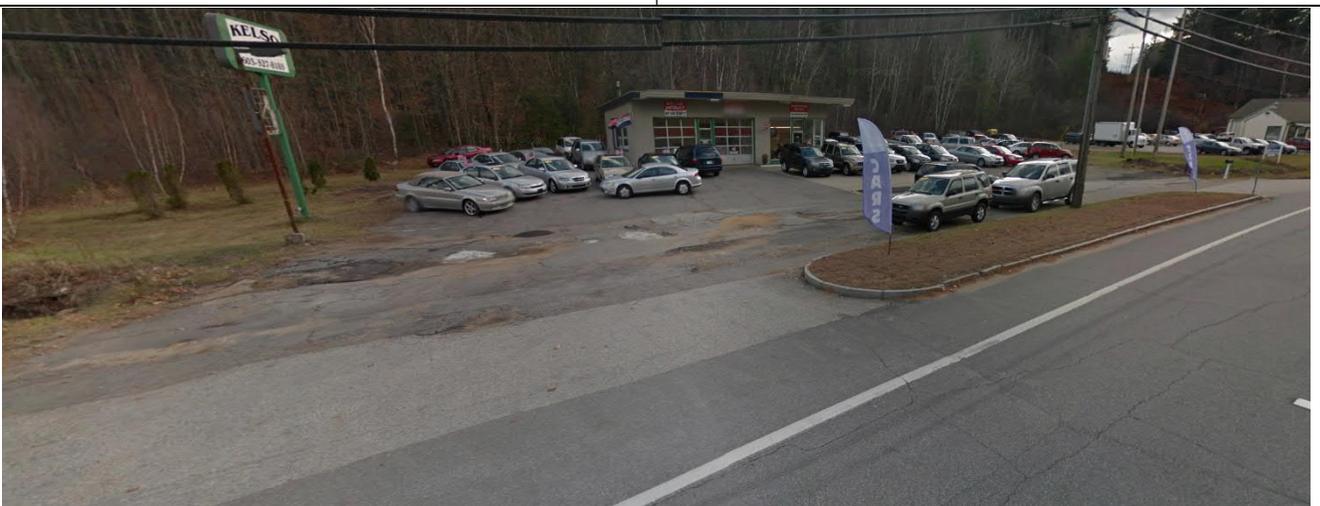
Kelso Motors Frontage. Restore stream (140 LF) leaving single entrance drive

- Under Kelso Motors Frontage (Project #3B). 180' length could be reduced to 40'. Owner would lose 0.2 acres of land on which cars are currently displayed. The existing culvert is actively failing, with subsistence of the land above it requiring maintenance by the owner.

Note failing pavement due to loss of underlying gravel into corroded culvert

Project Narrative Description (up/downstream limits, banks(s), etc):
 Excavate to remove the pipe, leaving enough (40' +/-) to maintain a 2-lane entrance.
 Construct new channel and floodplain. Space constraints will limit floodplain width.
 Pipe is in poor condition and inspection is needed to determine which portion to save.

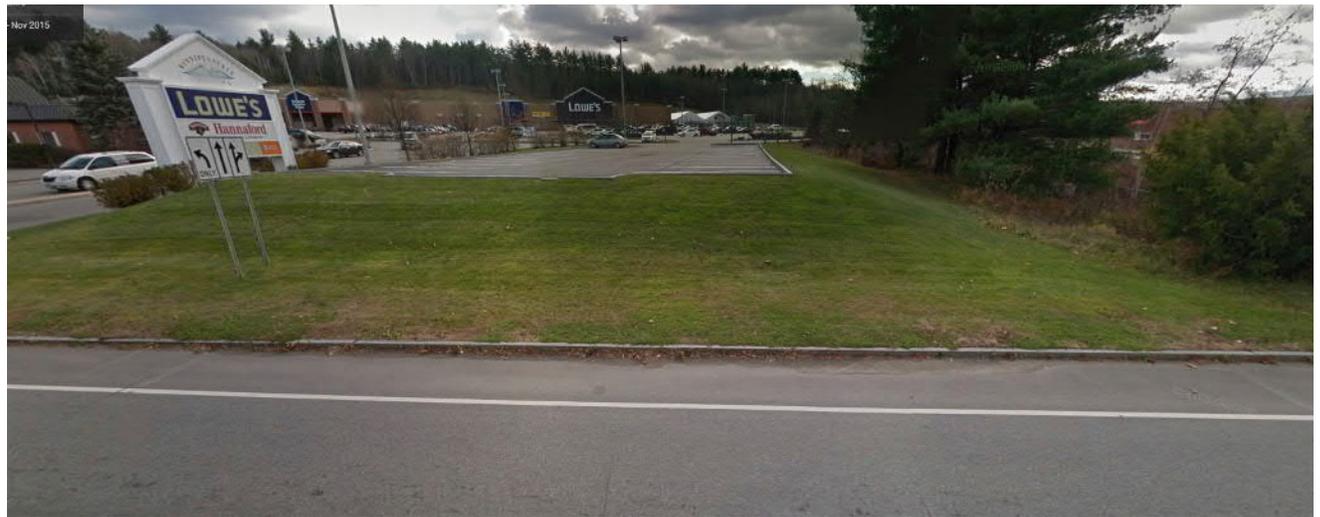
Lowes Overflow Parking. Restore stream (120 LF) and create floodplain and wetland

Site Issues and Relevance to the Watershed Plan Objectives:
 Removing the pipes restores channel and floodplain that can absorb water and sediment reducing the burden on downstream reaches and Paugus Bay. .

Project Narrative Description (up/downstream limits, banks(s), etc):
 Excavate to remove the pipe and construct a new stream channel. Create a new floodplain in the space available. At the Lowes site, create and expanded floodplain with wetland to provide flow attenuation.

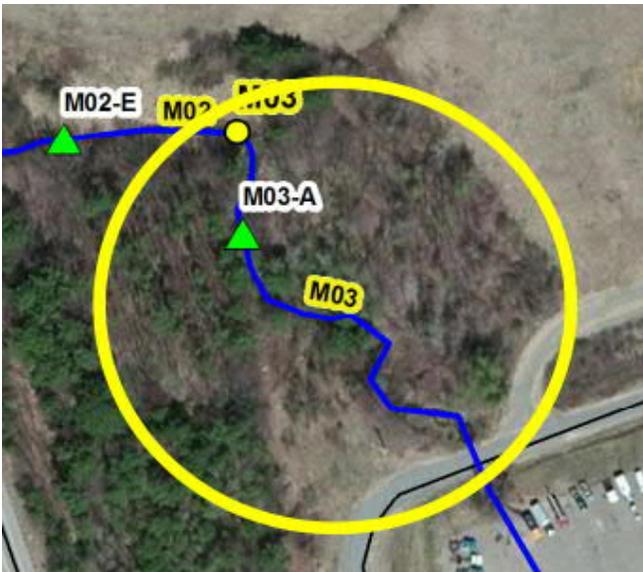
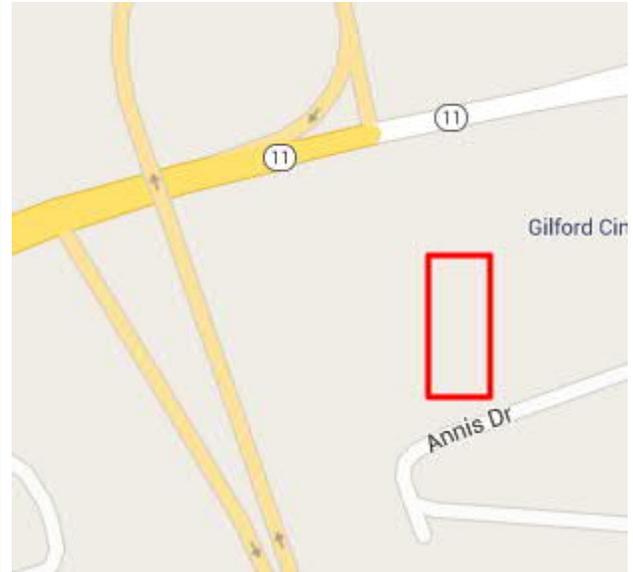
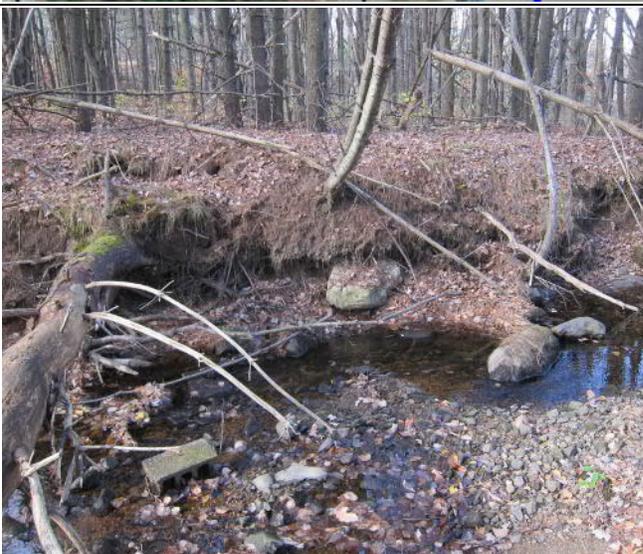
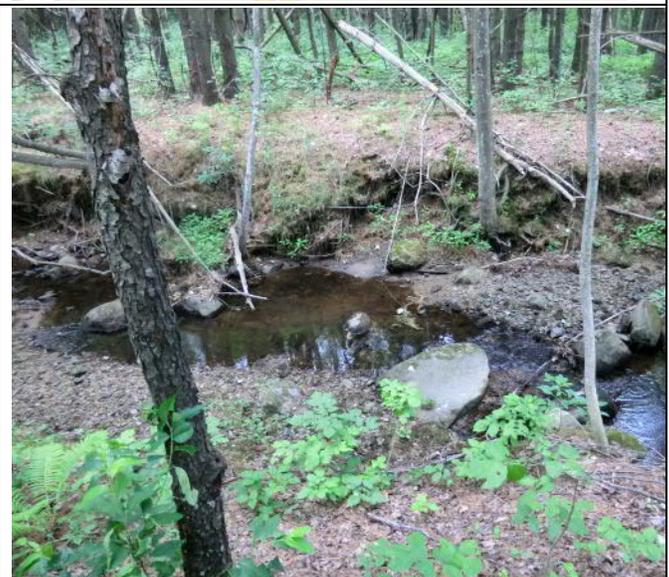
Incised channel with continuously failing banks

Project Narrative Description (up/downstream limits, banks(s), etc):
 Excavate banks to create floodplain at appropriate elevation. Seed and densely plant exposed banks.
