# LAKE WINNISQUAM WATERSHED-BASED PLAN

**PREPARED BY FB ENVIRONMENTAL ASSOCIATES & HORSLEY WITTEN GROUP**

JULY 2022 | **FINAL**

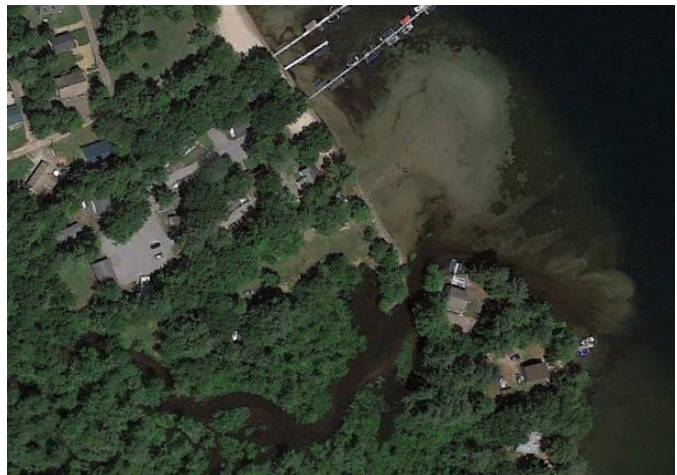
Aerial view of a 300-ft radius sediment delta at the outlet of Black Brook as it enters Lake Winnisquam.

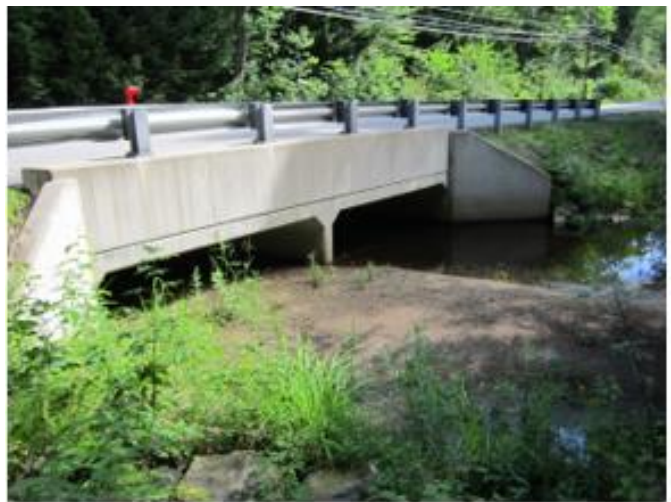
Sedimentation evident at a new box culvert along Black Brook at the Black Brook Rd crossing. Photo courtesy of Lang (2021).

In 2021, BCCD hired an engineer (G. Lang, P.E.) to review and assess environmental issues affecting the water quality of Black Brook with emphasis on assessing the cause of sedimentation altering flow conditions at a newly installed box culvert at the Black Brook Rd crossing. Previous studies reviewed in preparation for the field assessment included the 2012 *Black Brook Watershed Management Plan* (AECOM, 2012) and the 2020 *Summary and Final Documentation, Sanbornton Roadway Evaluation* (Underwood Engineers, Inc., 2020). Lang (2021) found sediment loading issues coming from Huse Road, Kaulback Road, Woodman Road, and Black Brook Road. Lang (2021) also assessed sedimentation at the new box culvert on Black Brook Rd, as well as significant trash and organic material blocking a stop-log structure downstream of the box culvert, and recommended that the stream be surveyed for proper channel grade and backwater effects from the blockage. Lang (2021) recommended that the existing sediment at the box culvert be removed down to the design gravel bottom before opening up the stop-log dam to prevent the sediment from washing into Lake Winnisquam with normal flows restored. A bypass channel may need to be considered to prevent the situation from reoccurring in the future.

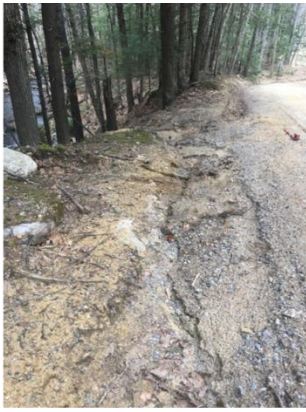
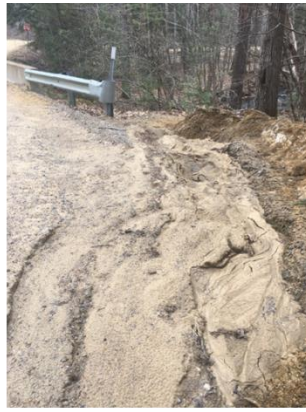
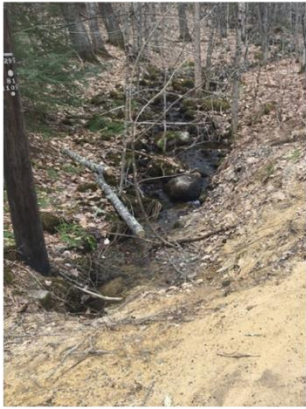
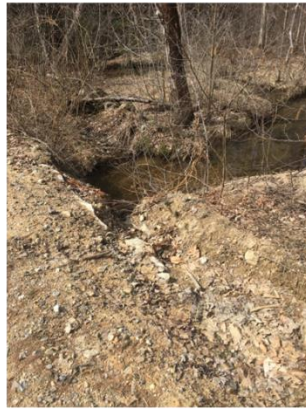
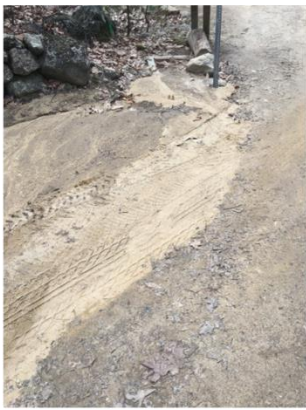
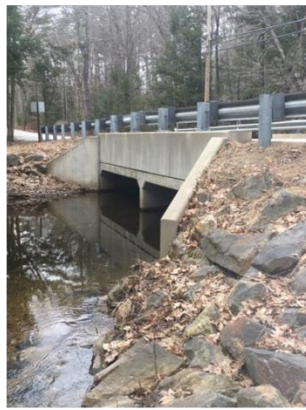
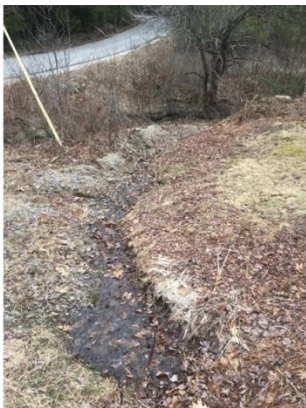
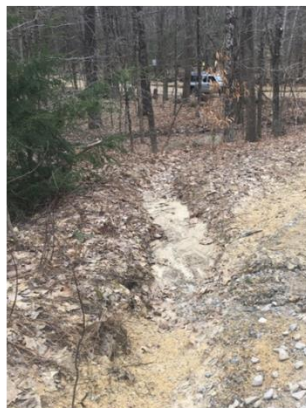
Photos of 11 evaluated and prioritized remediation sites in the Black Brook sub-watershed in Sanbornton. See FBE (2022) for more details. Refer to Figure 12 for site locations.

In 2022, FBE was hired by BCCD to perform a quantitative evaluation of 11 erosion and sedimentation sites in the Black Brook watershed, based on review of sites identified in the 2012 *Black Brook Watershed Management Plan* (AECOM, 2012) and the 2021 *Black Brook Watershed Assessment Update Report* (Lang, 2021). The evaluation results were used to prioritize the 11 sites for implementation and ultimately to serve as supporting documentation for future grant funding applications (site locations identified in Figure 12 and pictured on the next page). During the field visits, FBE evaluated the severity of erosion, collected measurements (length, width, depth) for screening-level erosion volume estimates, noted distance to the nearest surface water, flow condition, and sediment type (silt, sand, and/or gravel), and took representative photos of the sites. These observations were input to the Water Erosion Prediction Project (WEPP) model for estimating pollutant loading from each site. Site prioritization integrated WEPP model results and field observations through a quantitative ranking method (refer to FBE, 2022 for details). The three highest priority sites occurred along Huse Rd where runoff drains to Black Brook south branch, followed closely by Kaulback Rd where most runoff drains to Black Brook north branch. Both roads are unpaved gravel roads on steep slopes, transporting sediment to nearby surface waters.

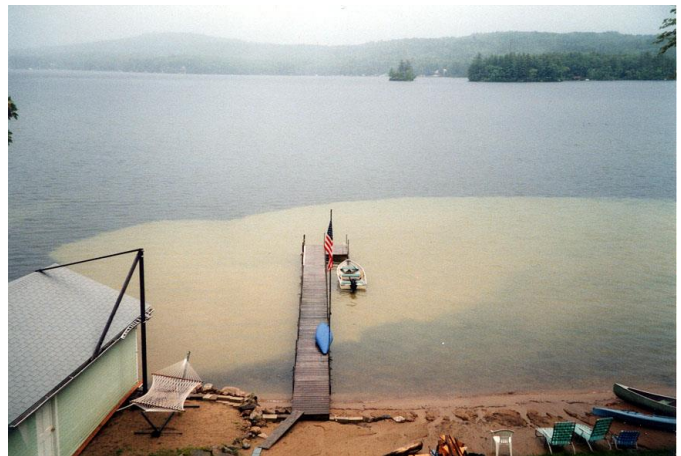
Plume of sediment washing into Lake Winnisquam from Batchelder Hill Rd in Meredith in the 1990s. The problem has since been remediated when the Town paved the road and installed a sediment forebay.

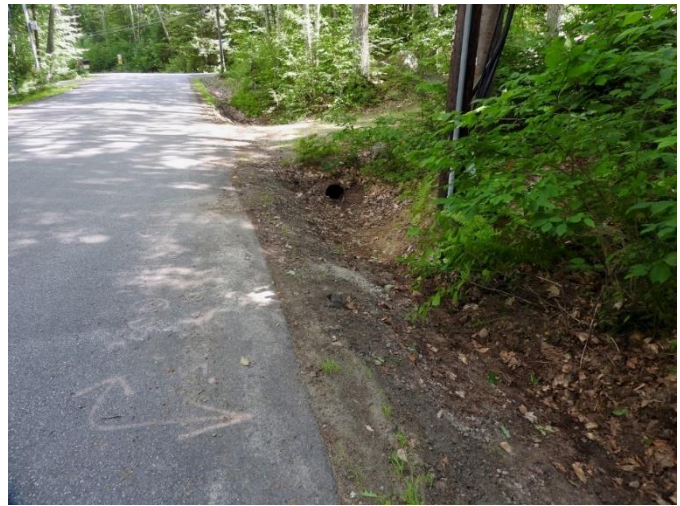
Example of a road ditch with accumulated sediment and vegetation scraped out to maintain hydraulic capacity, as part of the town's maintenance practices.

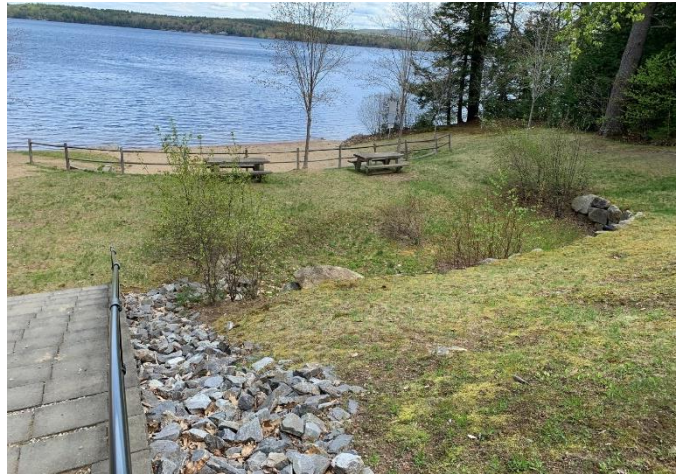
Example of structural BMPs installed at the Sanbornton Town Beach.

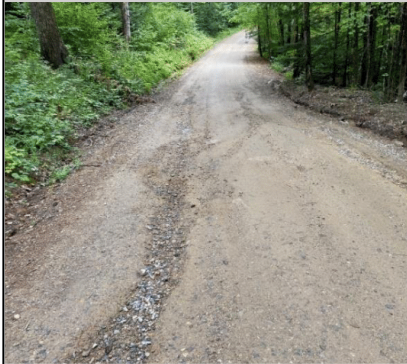
Erosion along Kaulback Road.

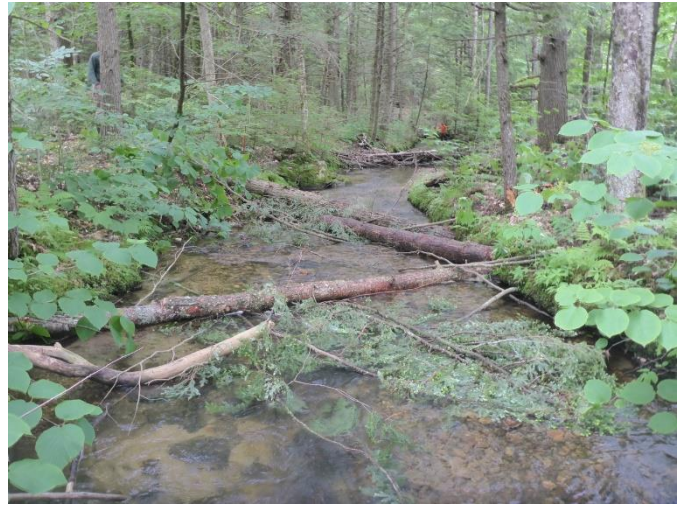
The felling of large woody material was completed in a one mile segment of Black Brook as part of a stream habitat restoration project in 2021 by the BCCD and Trout Unlimited.
