# Geomorphic Assessment Report and Watershed Plan

## Black Brook

### Laconia and Gilford, New Hampshire

Prepared for:  
City of Laconia

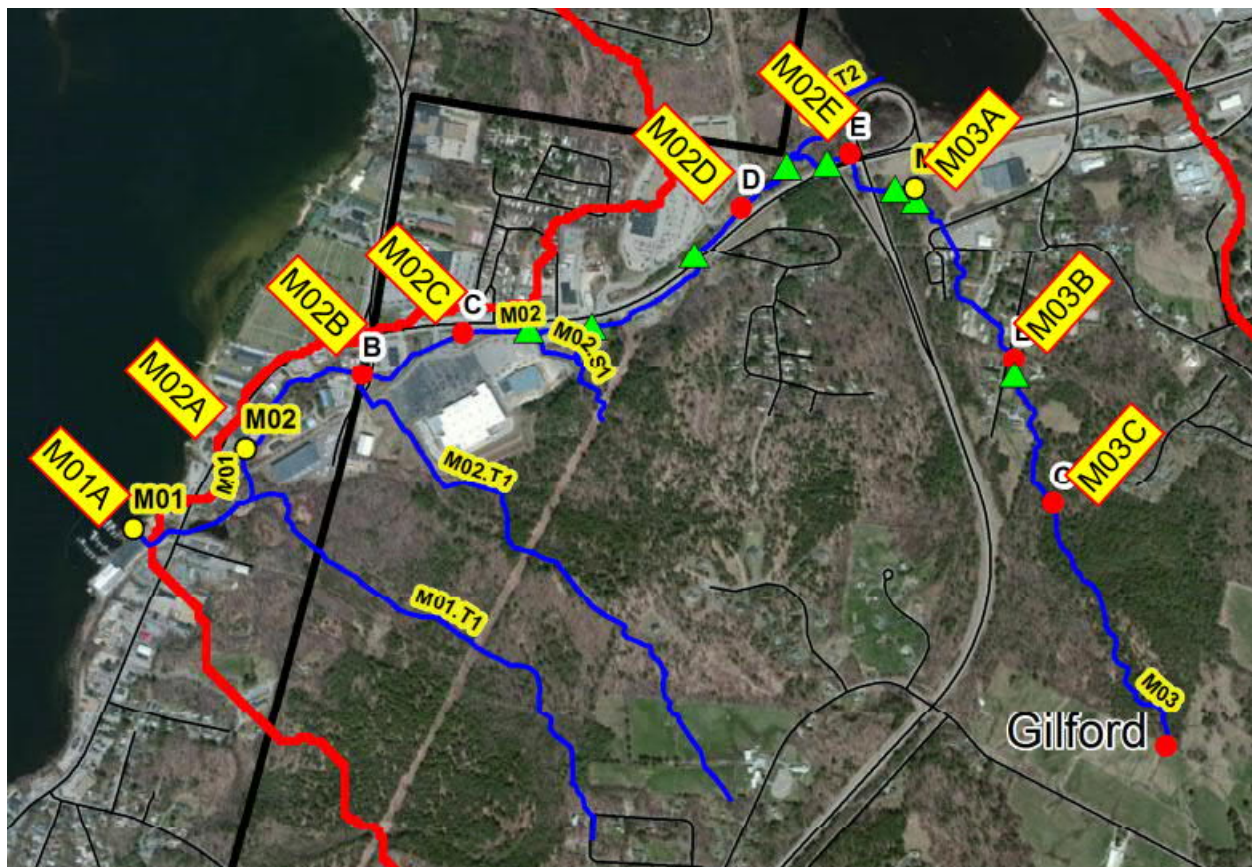
The assessed portion of Black Brook was broken into three reaches. The upstream limit of backwater from Paugus Bay marked the break between the first and second reach. A change in confinement indicated by reduced valley width was used to break the second and third reach. The reaches are labeled M01, M02, and M03 (M for mainstem as opposed to T for tributary) beginning at the mouth and moving upstream<sup>1</sup>. During Phase II, the reach break locations were confirmed in the field and were further subdivided into shorter segments that share similar characteristics. A total of 8 segments were identified – one in reach M01 (i.e., no further subdivision), five in reach M02, and two in reach M03. Figure 3 identifies the reaches and segments.

Figure 3. Black Brook Reaches and Segments

<sup>1</sup> The labeling in this study of Black Brook Mainstem Reach 3 (M03) and Tributary M02T2 is reversed from the labeling included in statewide stream channel mapping (NH Hydrography Dataset), which shows the mainstem extending into Lily Pond rather than turning to the south. The labeling used in this study is consistent with local convention and understanding of the watershed.
