Geomorphic Assessment Report and Watershed Plan

Black Brook

Laconia and Gilford, New Hampshire

June 30, 2016. Revised July 7, 2016

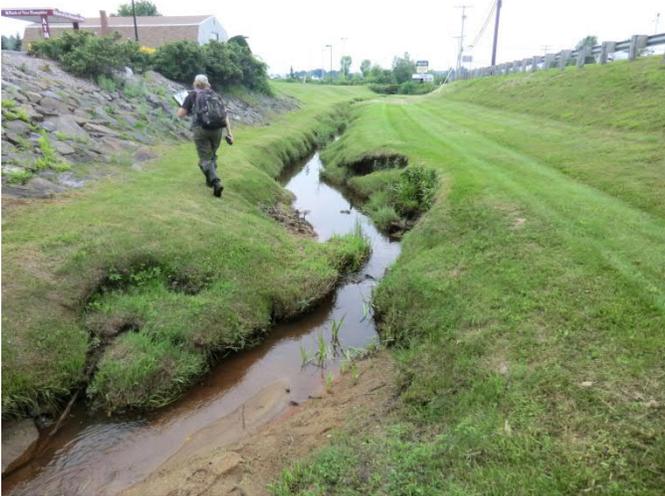
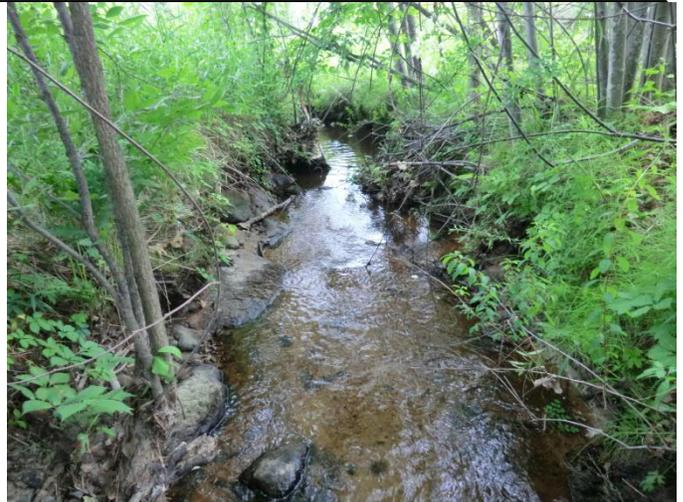
The channel in segment M02C is incised (Stage II of the Channel Evolution Model, CEM) and in some locations is widening (Stage III)². Significant fresh sediment deposits were noted in some channel locations as well as on the adjacent floodplain. The channel earns ratings of Fair (on the Poor-Fair-Good-Reference continuum) for both geomorphic and habitat condition. The changes in channel form (primarily incision) do not yet represent a change in stream type. As the channel responds to incision with eventual bank erosion and channel widening (as is predicted by the CEM), the changes will very likely be significant enough to represent a change in stream type throughout this reach.

² Field assessment data for this segment reports an incision ratio of 1.0, which would indicate no incision. However, we contend that it is indeed incised, and the field measurements are the result of the observed recent and highly mobile sediment deposits in the channel that mask the true channel depth as well as the lack of any natural vegetation that would normally be used to confirm the bankfull elevation in an incised channel (and would in this case have placed that elevation further down the bank below the elevation of incipient flooding).

Replacement culvert sizes should reflect what is known about the stage of channel evolution evident in the surrounding channel. For instance, the channel width in Reach M02C is approximately 7 feet, but we know the channel is incised, and thus some future widening can be expected. An appropriately sized culvert would be designed to span the future anticipated channel width.

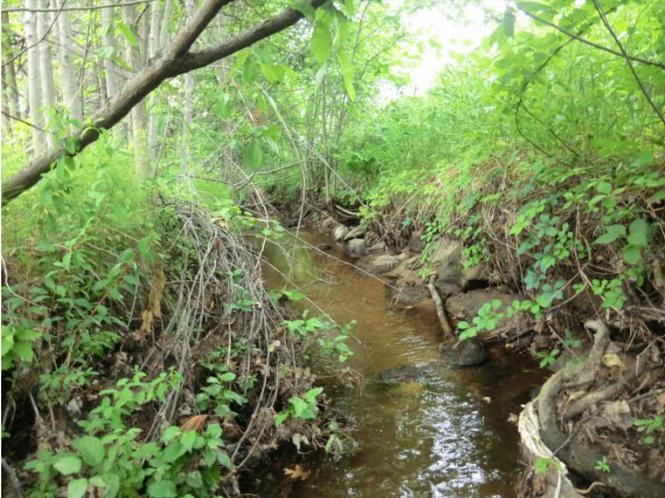
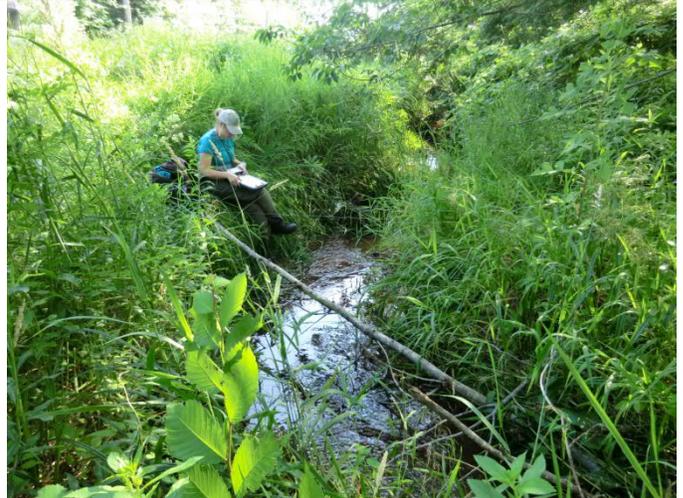
The channel in Segment M02D is generally stable and representative of Stage 1 of the CEM. Fresh sand and gravel deposits were observed in the channel and on the floodplain. The channel earns ratings of Good (on the Poor-Fair-Good-Reference continuum) for both geomorphic and habitat condition.

Conservation easements are recommended in areas currently free of existing development and stream stressors, in order to protect the integrity of the stream corridors from future encroachments. In the Black Brook Watershed, the land surrounding Reach M02D (largely between Lily Pond and Walmart) is an example of an area that would benefit from conservation easements to the extent it is not already conserved. This area currently provides significant flood and sediment load attenuation that has direct positive benefits to the more developed portions of the watershed downstream where sedimentation and flooding is a problem. The presence of conservation easements would ensure that this land continues to provide these benefits into the future.

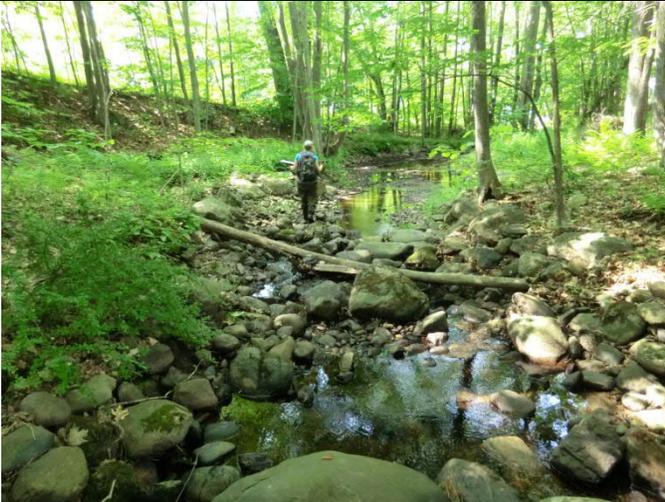
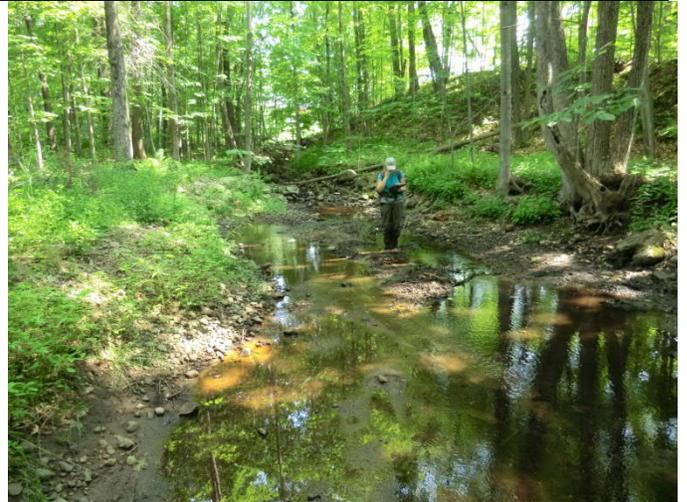
The channel in Segment M03B is generally stable and representative of Stage 1 of the CEM. Fresh sand and gravel deposits were observed in the channel and on the floodplain. The channel earns ratings of Good (on the Poor-Fair-Good-Reference continuum) for both geomorphic and habitat condition.

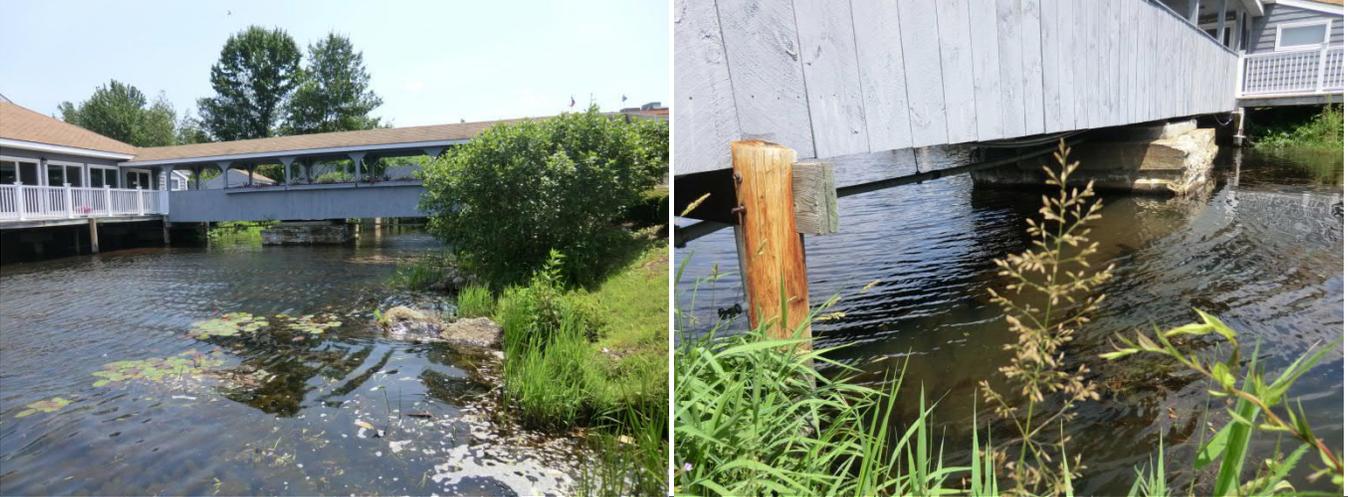
#	Reach	Road/Drive	Type	Span (ft)	Length (ft)	Notes
1	M01A	Private Pedestrian Walkway	Bridge	55	9	Timber with center pier on concrete

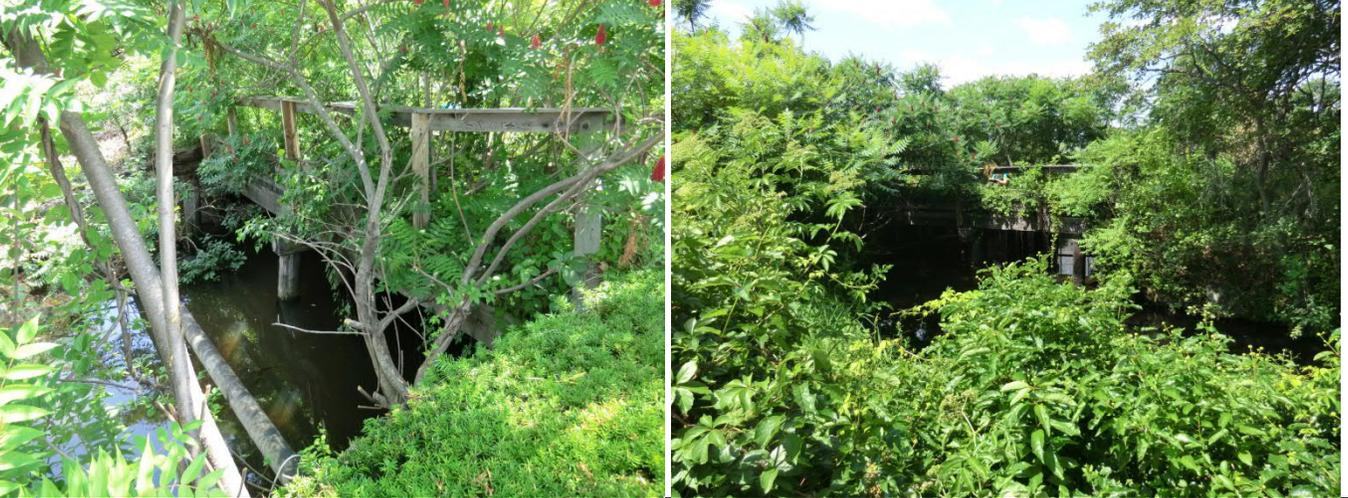
2	M01A	Railroad (abandoned)	Bridge	30	15	Old wood pilings piles

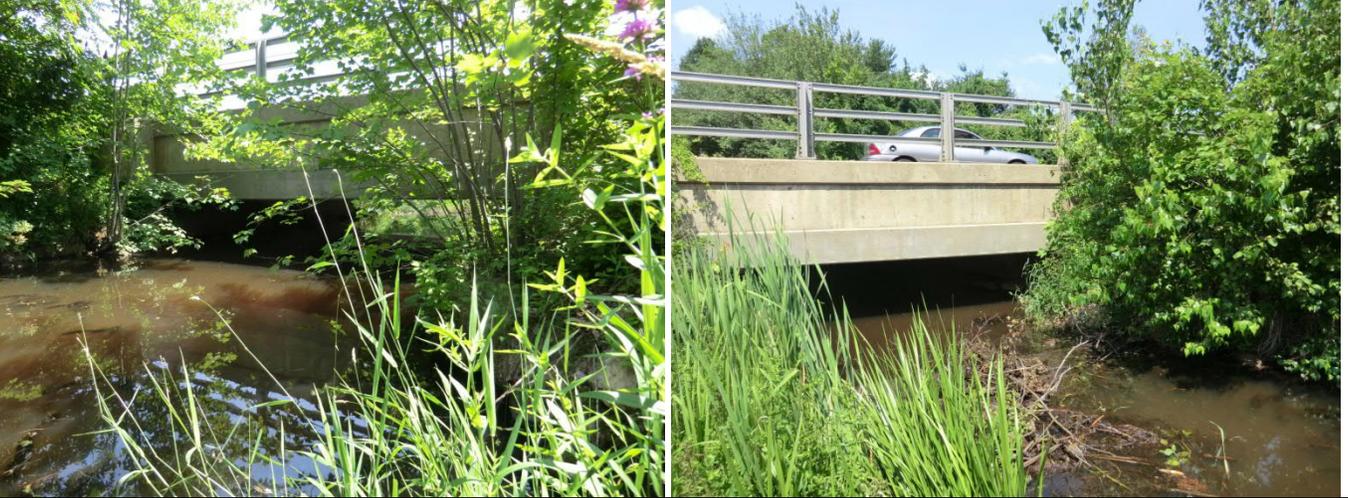
3	M01A	Union Avenue	Bridge	20	44	Modern concrete

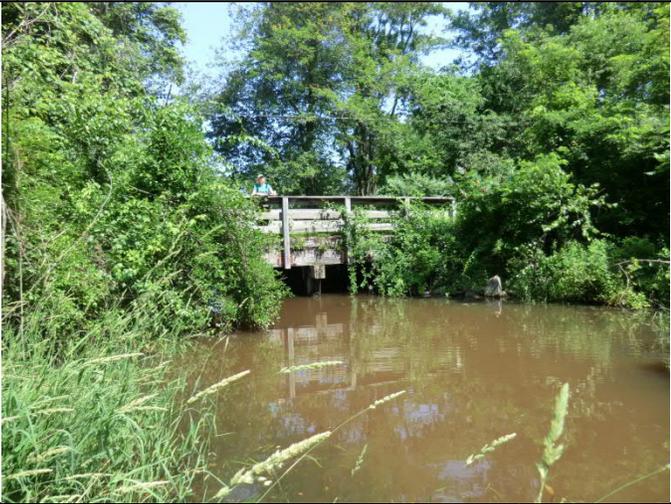
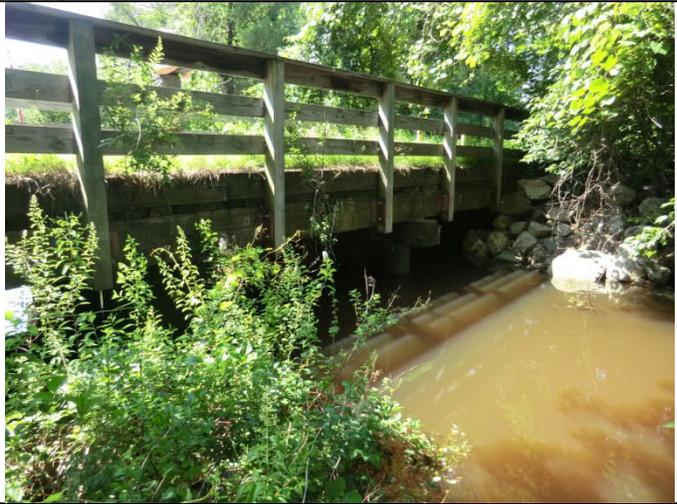
4	M01A	Ped/Bike Path	Bridge	32	15	Old timber

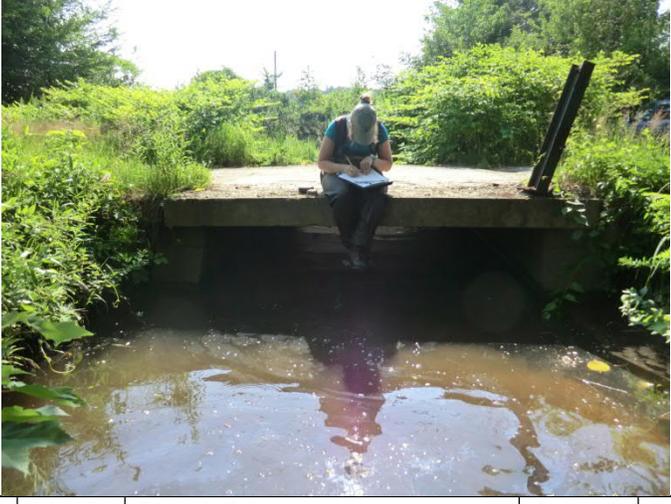
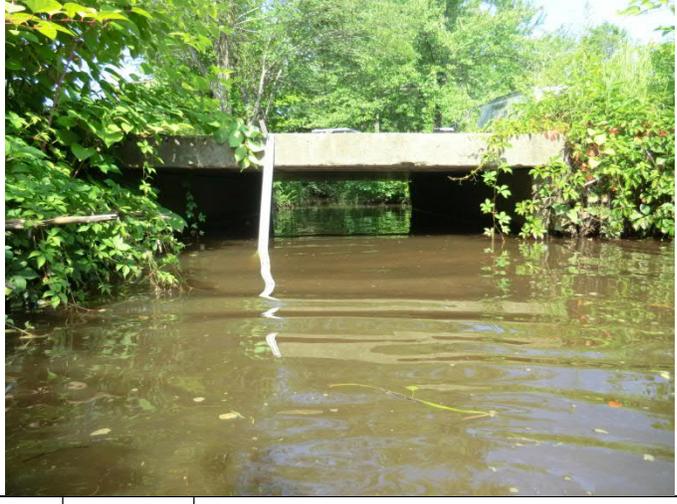
5	M02A	Laconia Ice	Bridge	9	20	Old concrete slab

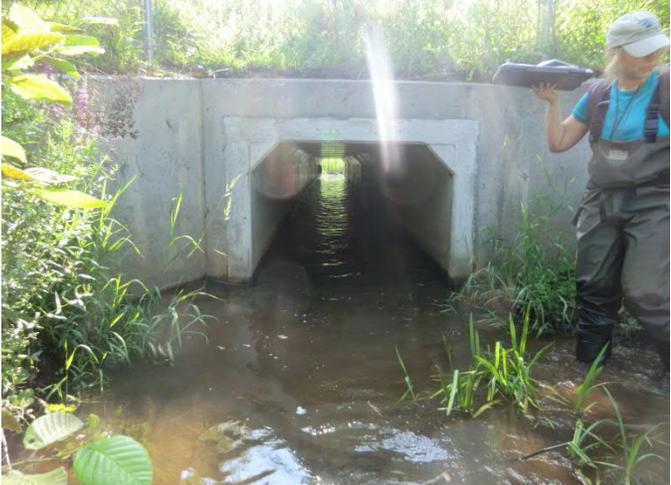
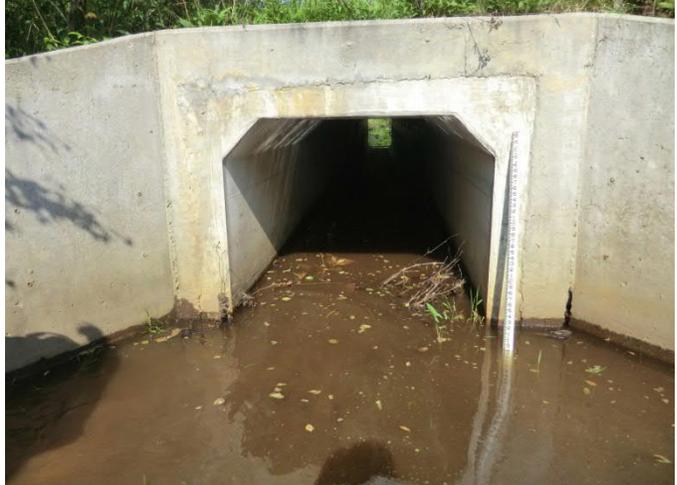
6	M02B	Blaisdell Avenue	Culvert	5	100	Concrete box

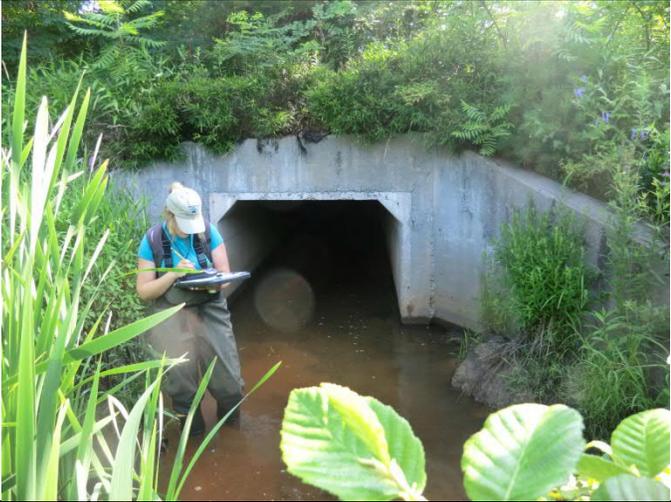
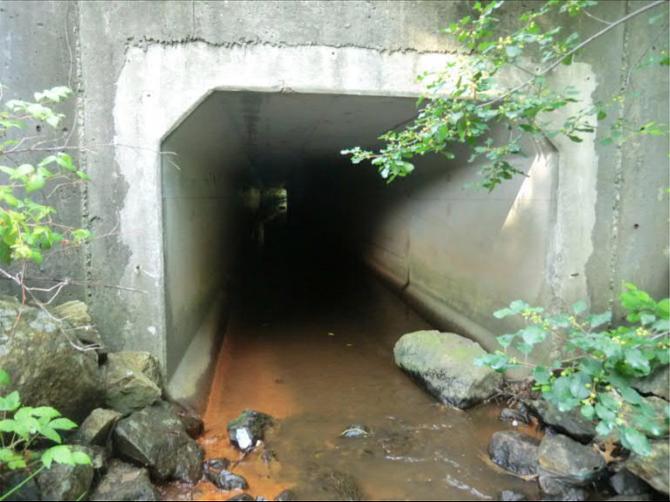
7	M02B	CVS Parking Lot	Culvert	6	200	Concrete box

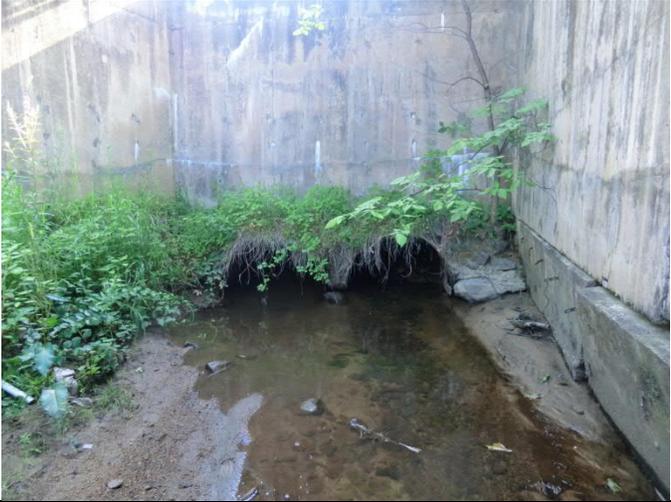
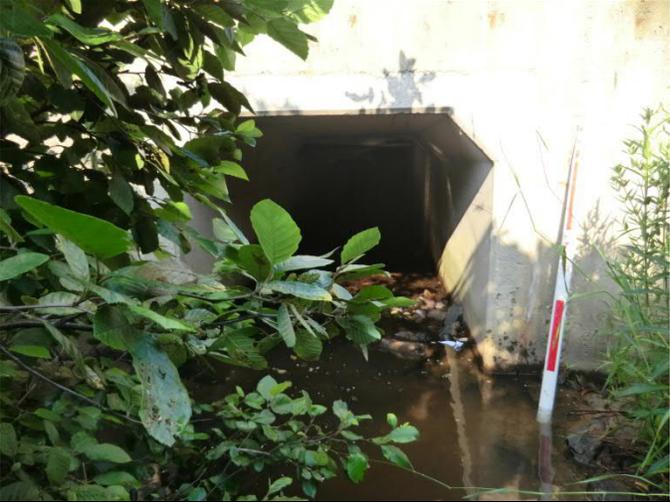
8	M02B	Meredith Savings Bank Lot	Culvert Culvert	4 (x2) 5	385	Double corrugated steel outlet Concrete box culvert inlet

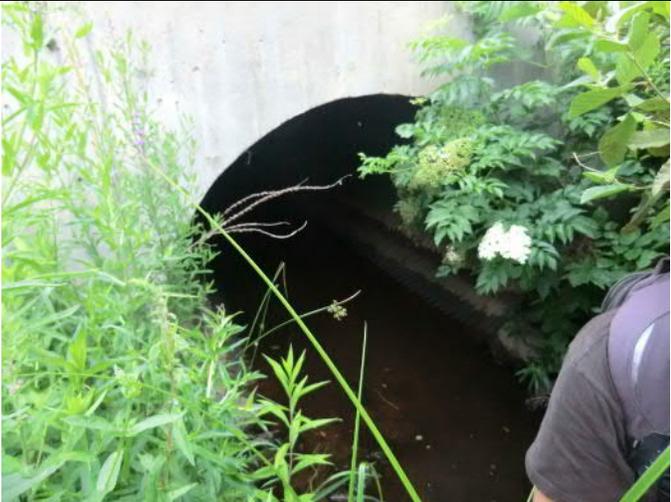
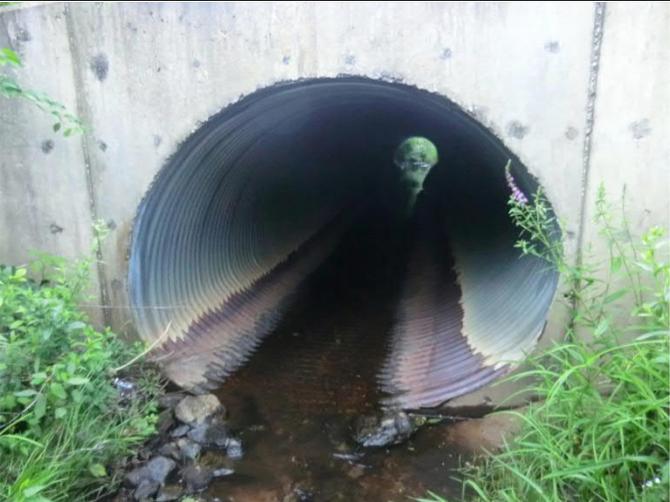
9	M02C	Hannaford Entrance Drive	Culvert	7	81	Elliptical corrugated steel

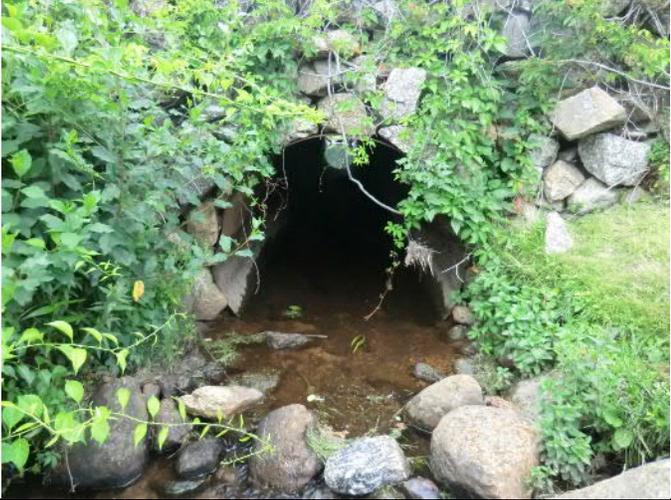
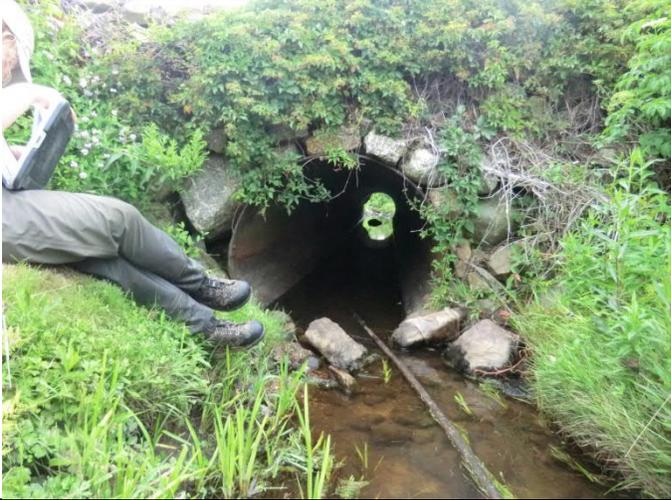
10	M02C	Wild Bird Depot Entrance	Culvert	4.2	64	Old smooth steel

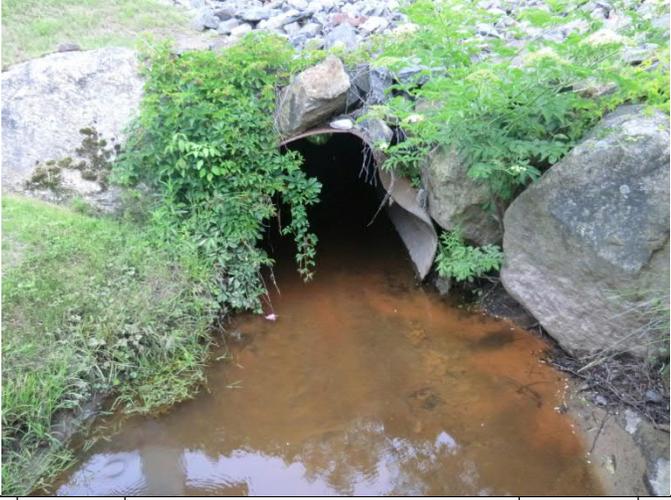
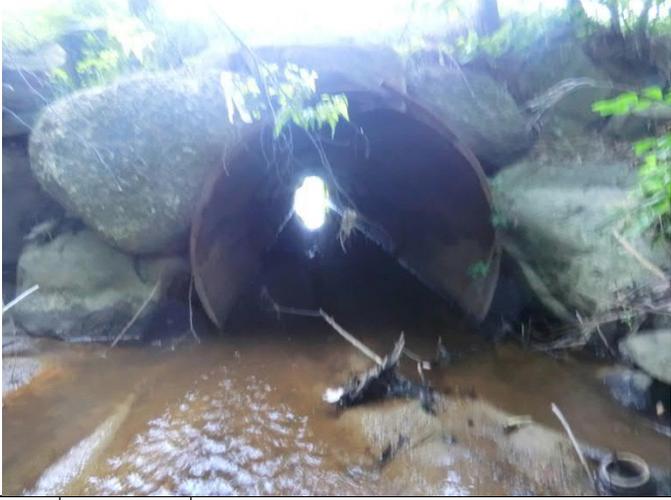
11	M02C	Bank of NH Entrance Drive	Culvert	4.4	62	Old smooth steel

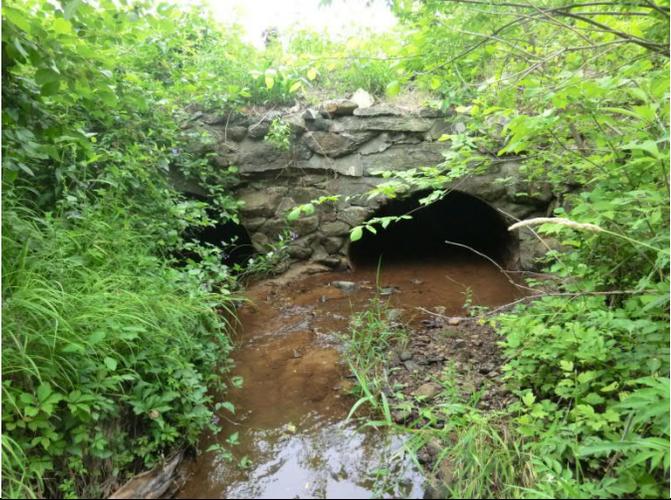
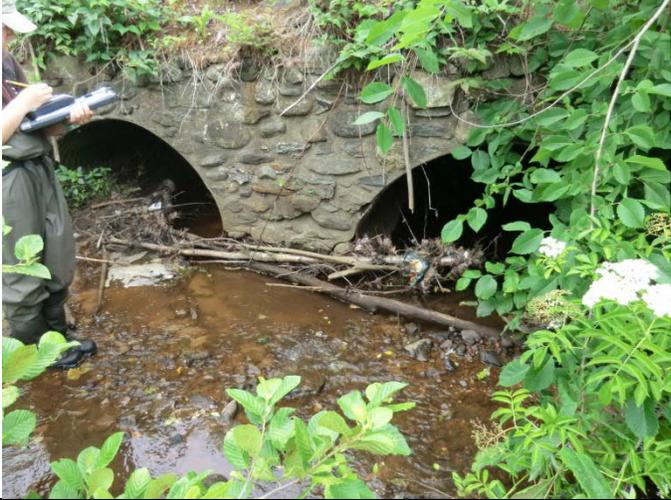
12	M02C	Electrical Substation	Culvert	5.3 (x2)	41	Double elliptical corrugated steel

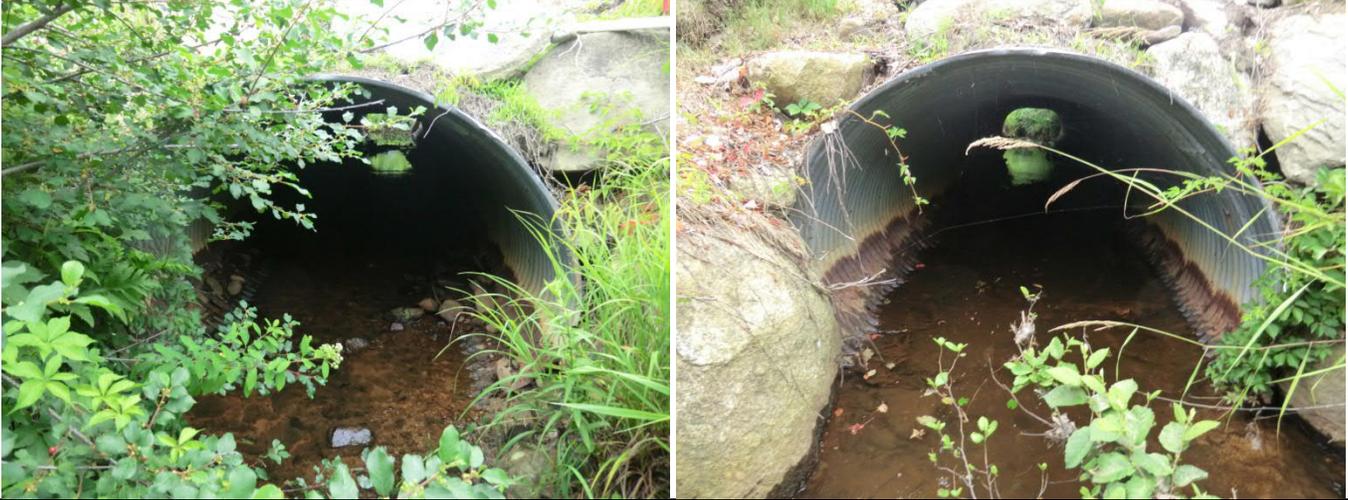
13	M02C	Country Cooking Entrance	Culvert	5.6	52	Corrugated steel

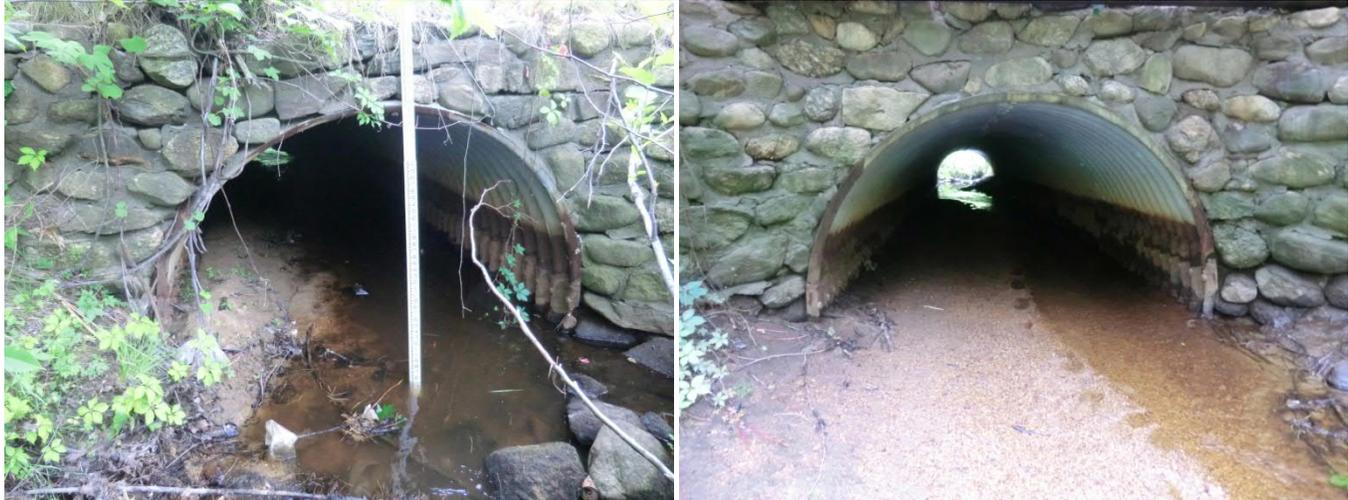
15	M02C	Lakeshore Road	Culvert	7	59	Corrugated steel ellipse

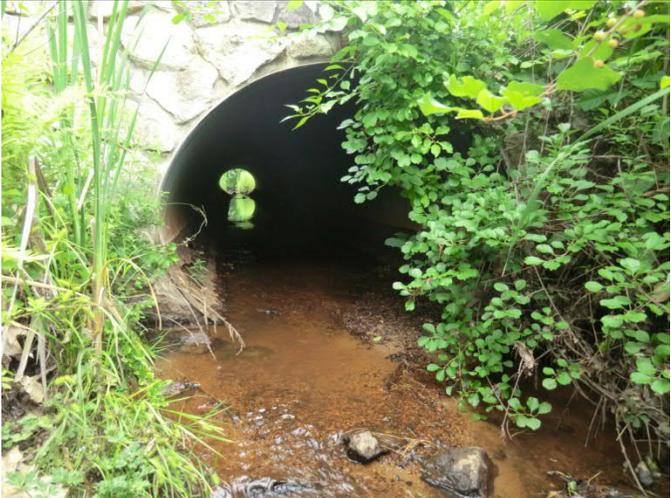
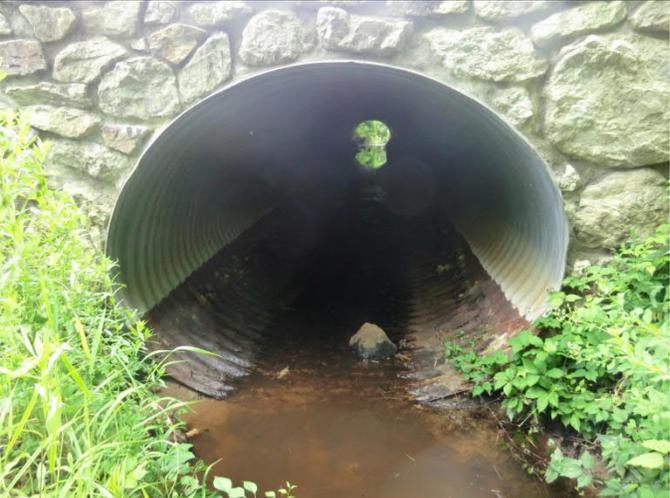
16	M02C	Walmart Entrance Drive	Culvert	6.9	95	Corrugated steel ellipse

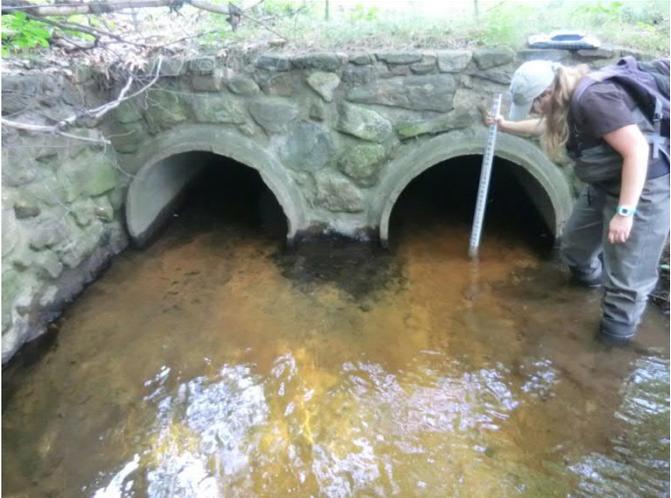
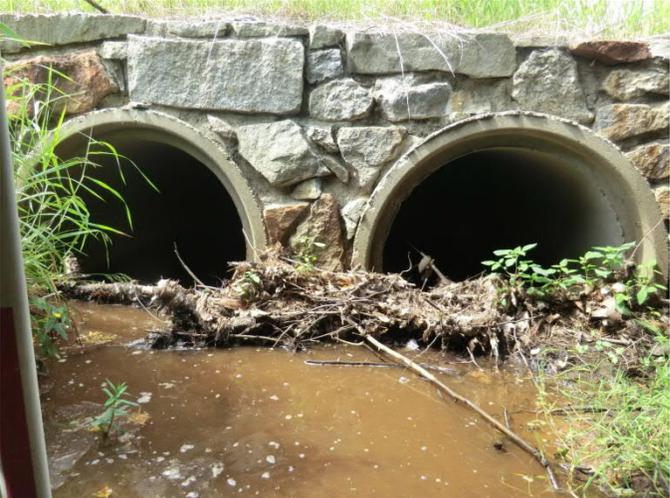
17	M02E	Lakeshore Road	Culvert	3.3 (x2)	102	Double barrel concrete pipes

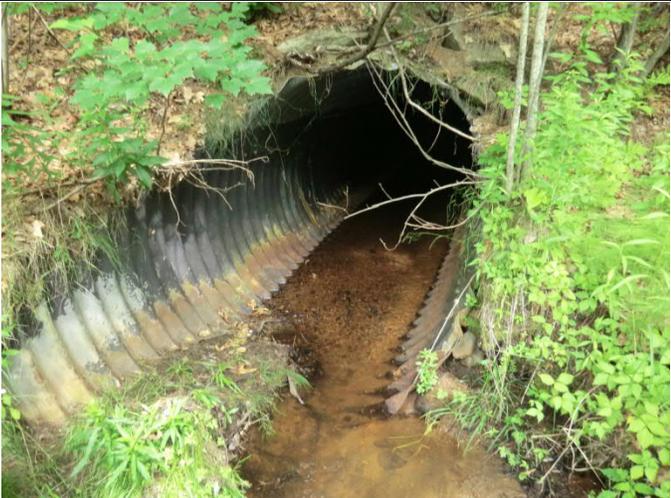
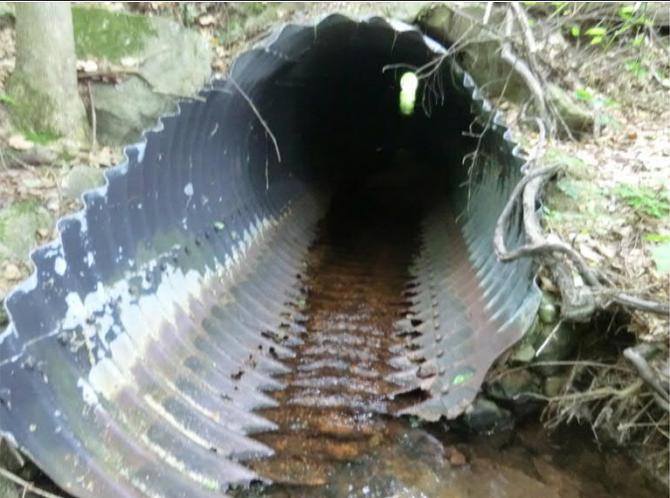
18	M02E	Rte 3	Culvert	6	190	Corrugated steel

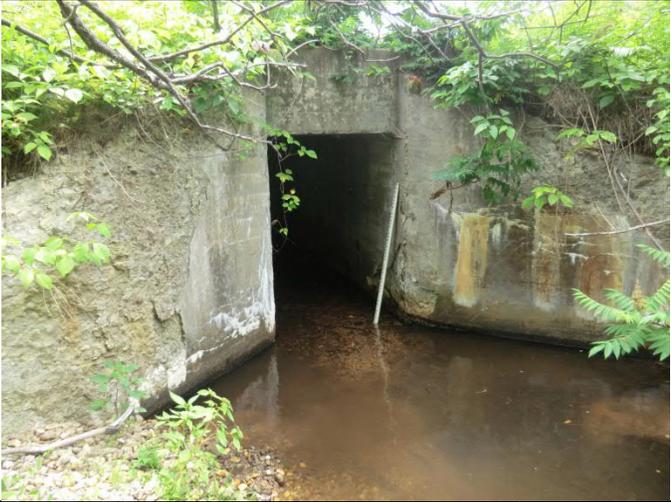
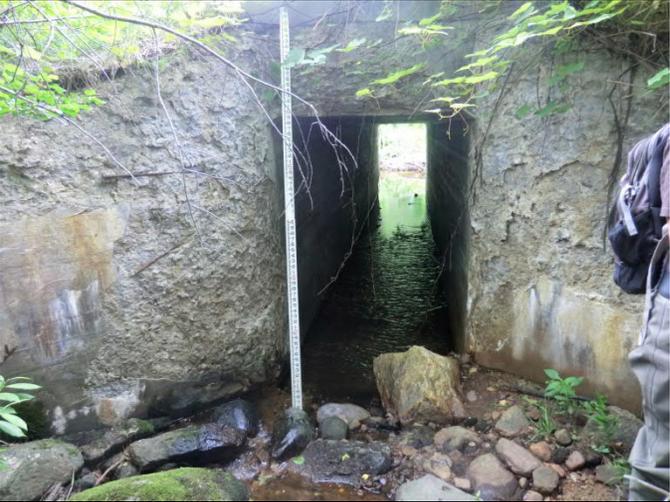
19	M03A	Annis Drive	Culvert	4	33	Concrete box

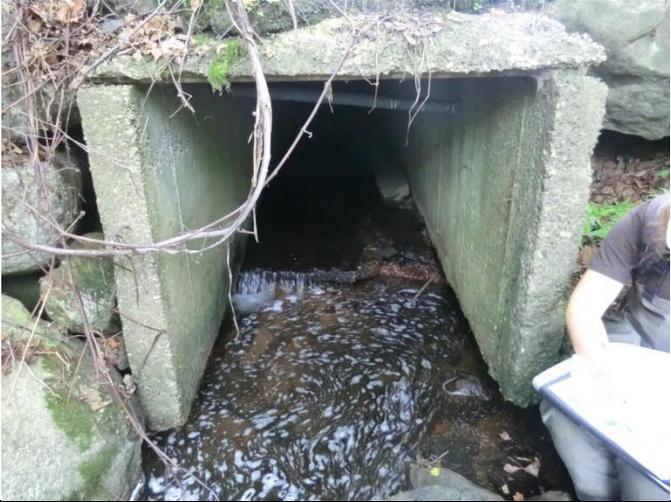
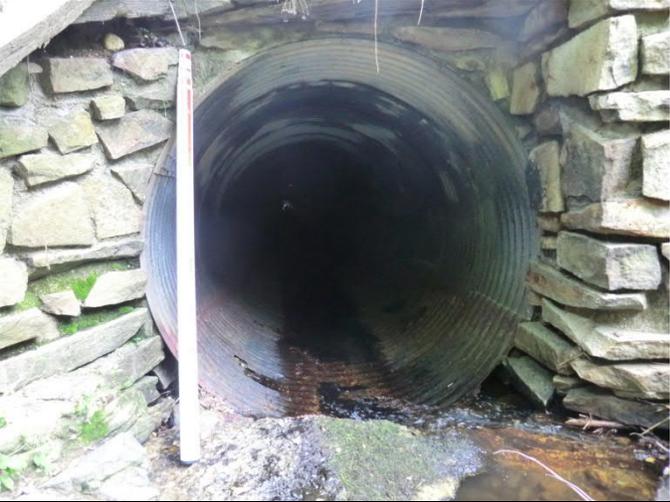
20	M03A	Parking Lot and Upper Annis Drive	Culvert	4 4.9	200	Concrete box outlet Corrugated steel inlet

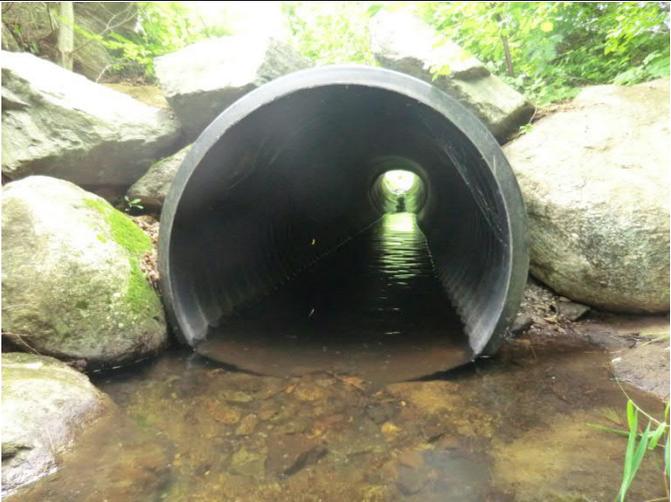
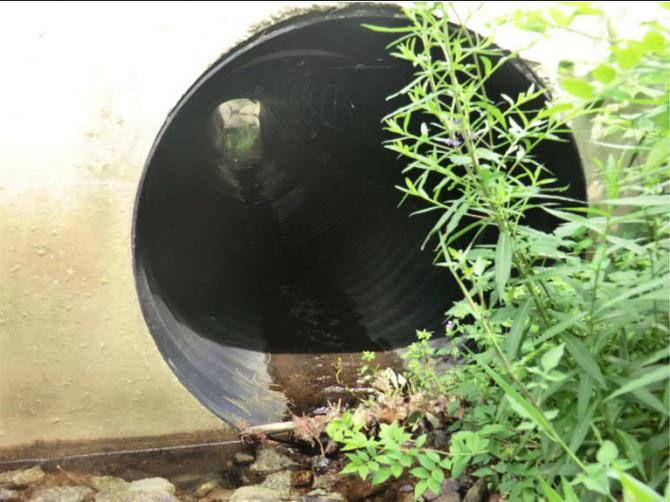
21	M03A	Mulberry Road	Culvert	4.9	81	Corrugated plastic

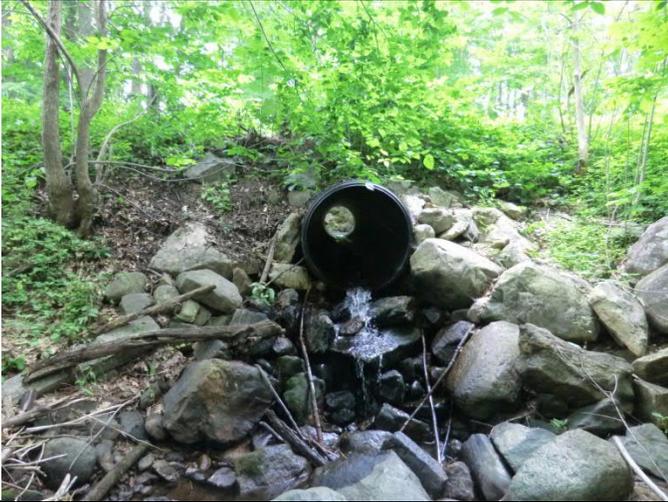
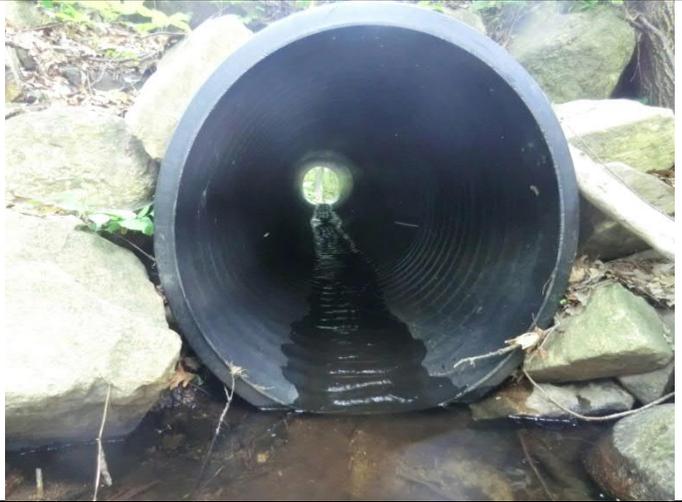
22	M03A	Bretton Road	Culvert	3.9	49	Corrugated plastic
----	------	--------------	---------	-----	----	--------------------

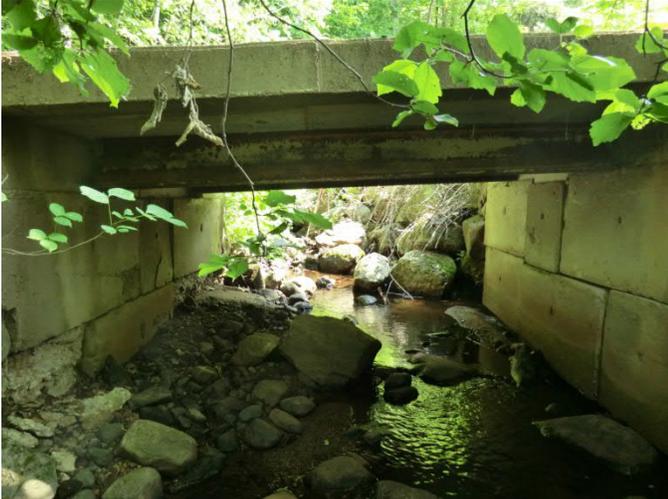
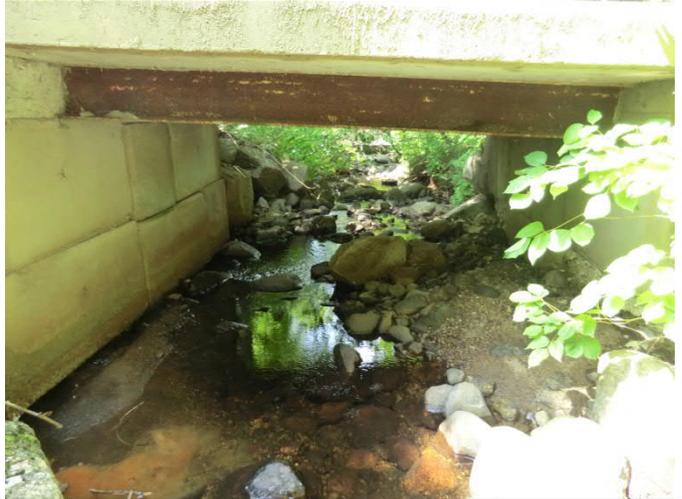
23	M03B	Priv drive off Bretton	Bridge	8	12	Concrete slab on blocks
----	------	------------------------	--------	---	----	-------------------------

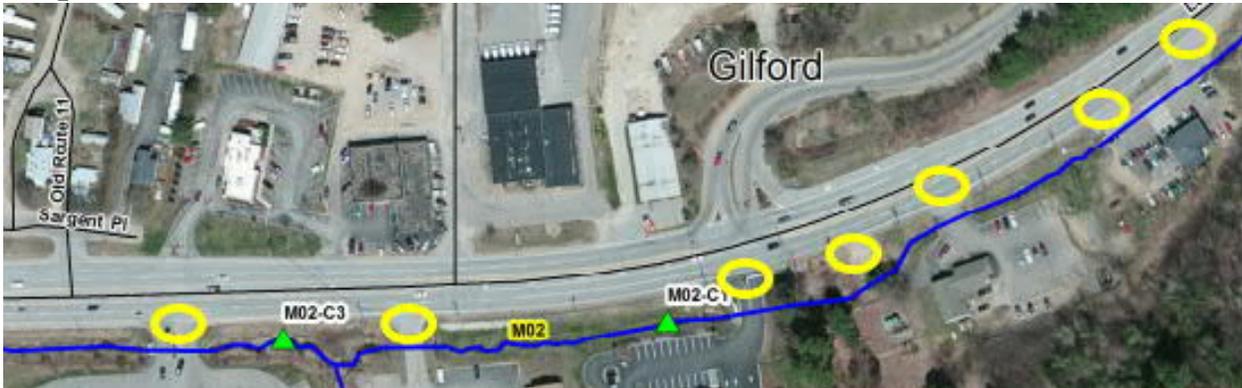
Map 1

Selected undersized culverts in Reach M02B that are candidate for replacement. All from Blaisdell Avenue upstream are undersized, in addition to those shown on map above.

Site Issues and Relevance to the Watershed Plan Objectives: Eighteen of the 23 culverts on Black Brook are smaller than the channel and this disrupt the flow of water and sediment and contribute to channel instability. While impacts may be localized, the sheer number of culverts makes the impacts systemic.

Project Narrative Description (up/downstream limits, banks(s), etc):
 Replace culverts with aluminum pipe arches that are recessed below the channel with the channel bottom reconstructed inside. Tapered ends can be used to eliminate expense of concrete headwalls. Width of 12-14 is suitable for all locations.

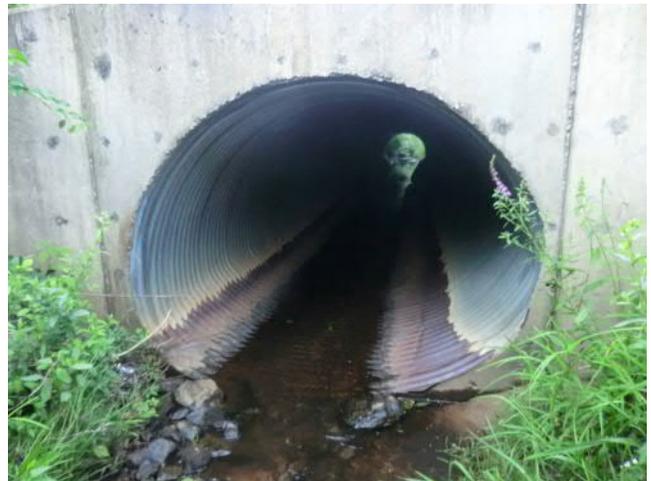
Photo 2

Another typical undersized culvert:

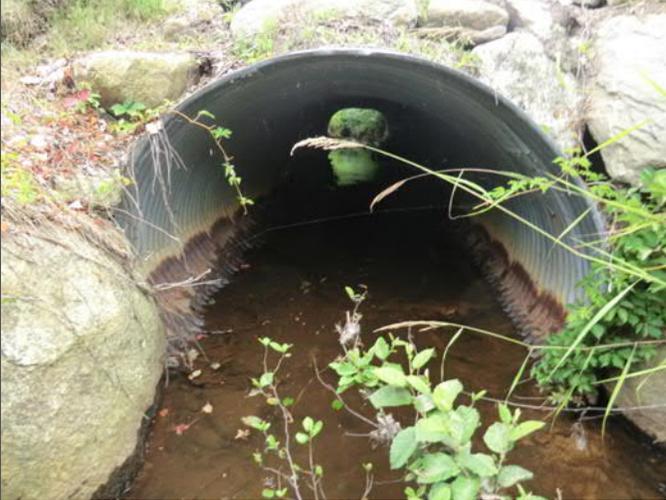
<p>Photo 1</p>

<p>Country Kitchen culvert</p>	<p>Photo 2</p>

Site Issues and Relevance to the Watershed Plan Objectives:
 Every linear foot of culvert represents a linear foot of lost natural channel and functioning floodplain. Eliminating a typical entrance culvert would restore approximately 40 linear feet of channel and associated floodplain.

Project Narrative Description (up/downstream limits, banks(s), etc):
 Remove an existing culvert and restore the natural stream channel and floodplain. Construct improvements on the ground to allow convenient access to the site from the neighboring culvert that remains. Since substation traffic is certainly less than for the restaurant, initial design effort would focus on eliminating the substation culvert.

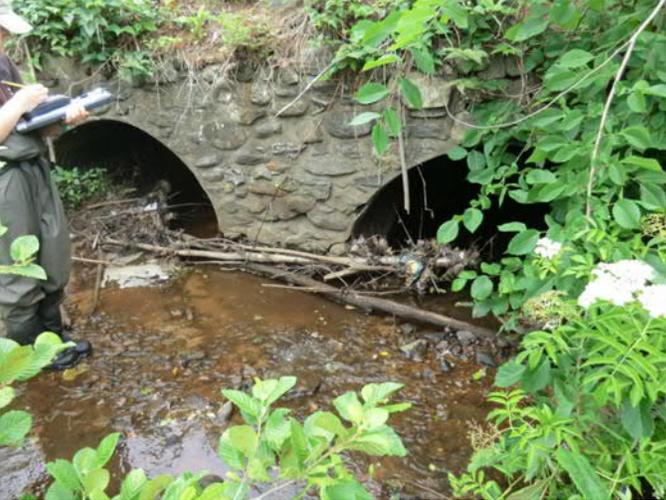
<p>Electrical substation dual culverts</p>
--	---

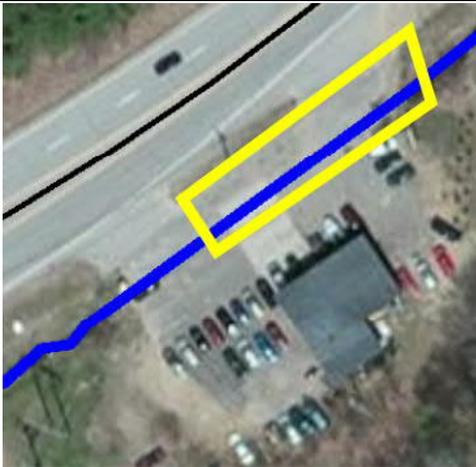
Location: Kelso Motors Frontage

Note failing pavement due to loss of underlying gravel into corroded culvert

Kelso Motors Frontage. Restore stream (140 LF) leaving single entrance drive

Project Narrative Description (up/downstream limits, banks(s), etc):
 Excavate to remove the pipe, leaving enough (40' +/-) to maintain a 2-lane entrance.
 Construct new channel and floodplain. Space constraints will limit floodplain width.
 Pipe is in poor condition and inspection is needed to determine which portion to save.

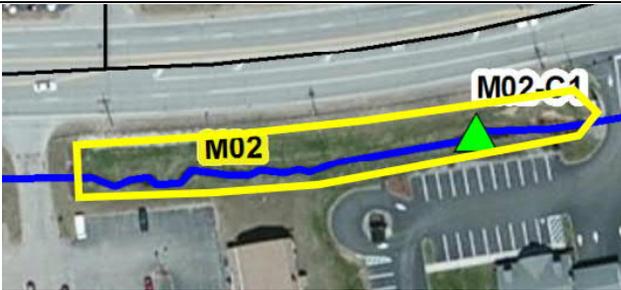
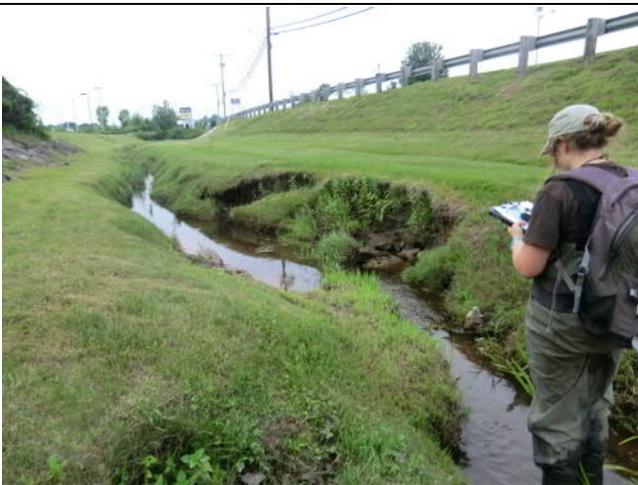
Location: Bank of New Hampshire

Site Issues and Relevance to the Watershed Plan Objectives:
 There is floodplain at the site, but without vegetation it is not as effective as it could be at reducing flood velocity and trapping sediment. Further, the banks are more prone to erosion without vegetation. Tax maps suggest downstream portion of mowed floodplain owned by downstream building owner, though that owner says it is owned by the bank.

Field Assessment Date: March 2016	Assessed by: MTM	Pg 2/2						
Project Type General Structural Non-Structural								
Project Type Specific Bank stabilization Wall Stabilization Dredging Stormwater Control Culvert replacement Landowner Outreach FEH Zone Mapping Restore Floodplain Access Easements <u>Riparian Plantings</u> Other _____								
Project Narrative Description (up/downstream limits, banks(s), etc): Plant the banks and floodplain densely with riparian shrubs. Bare root stock is acceptable. Incorporate larger specimen trees for aesthetics. Extend planting to downstream culvert.								
Site/Project Sketch:								
Considerations for Prioritization: These projects are relatively inexpensive, non-controversial, and effective, and thus should be made a high priority.

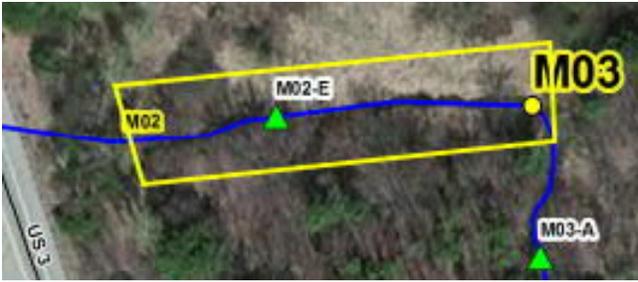
Reach M02E just upstream of the Bypass

Field Assessment Date:	Assessed by:	Pg 2/2						
Project Type General Structural Non-Structural								
Project Type Specific Bank stabilization Wall Stabilization Dredging Stormwater Control Culvert replacement Landowner Outreach FEH Zone Mapping Restore Floodplain Access Easements <u>Riparian Plantings</u> Other _____								
Project Narrative Description (up/downstream limits, banks(s), etc): Plant the banks and floodplain densely with riparian shrubs. Bare root stock is acceptable.								
Site/Project Sketch:								
Considerations for Prioritization: These projects are relatively inexpensive, non-controversial, and effective, and thus should be made a high priority.

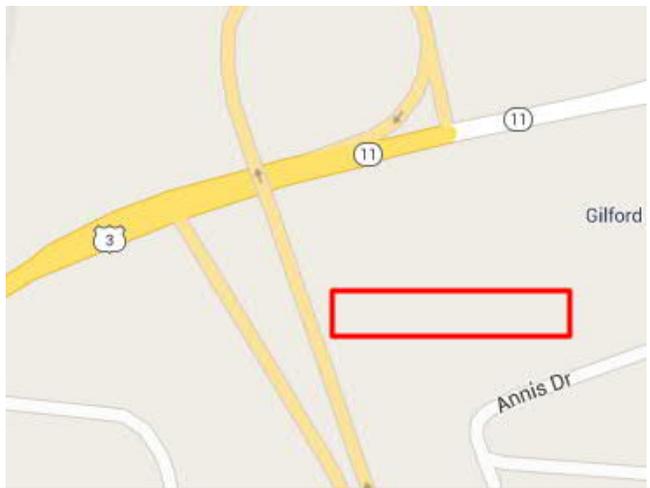
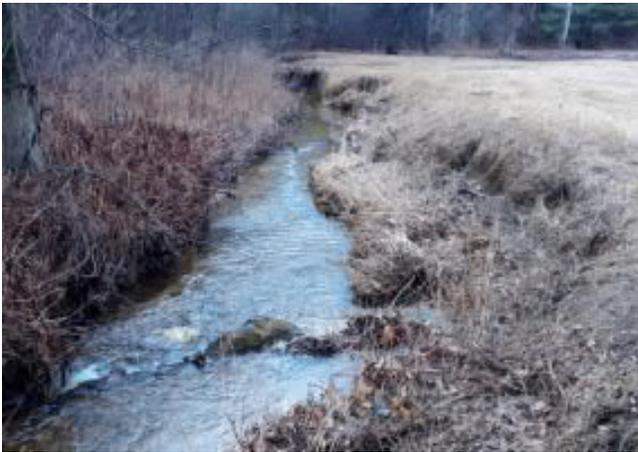
Unvegetated right bank in Reach M02E

Site Issues and Relevance to the Watershed Plan Objectives:
 There is floodplain at the site, but without vegetation it is not as effective as it could be at reducing flood velocity and trapping sediment. Further, the banks are more prone to erosion without vegetation.
